ELDORADO NATIONAL CRASH TEST

2007 Eldorado National Aero Elite 250

Title 49, CFR- Part 571.301 fuels system integrity

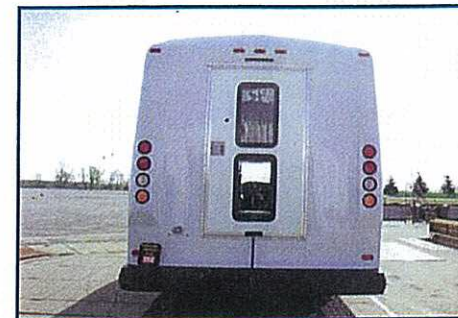
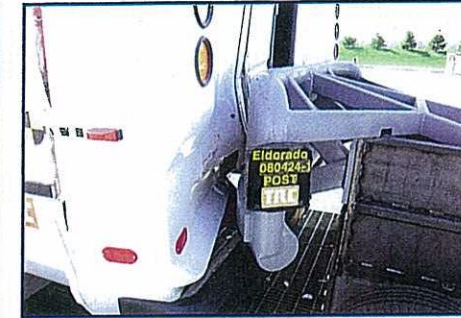
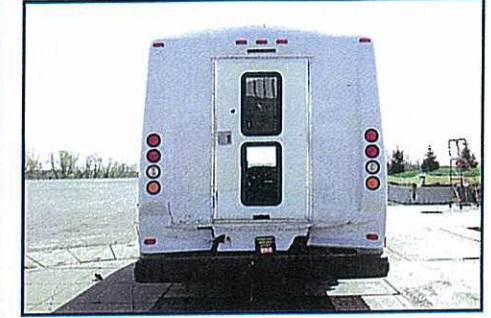
30 mph REAR impact by a 4,000 lb. moving barrier

Model selected represented the most vulnerable rear structure including rear emergency door. Rear to floor attachment sustained severe damage at area of impact and at lower rear to sidewall attachment point but remained intact. Permanent deflection was approximately 8". All seating in the impact area remained attached to wall and seat track mounting. 150 lb. bags of rock salt/ballast placed in each seat (simulating full passenger load) was unrestrained and cause some moderate damage to seat arm rests and stanchion poles. Rear emergency door remained functional. Fuel tank and system were unaffected.

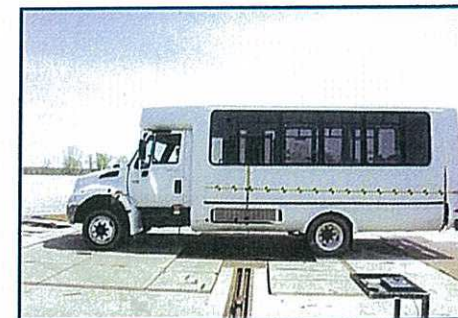
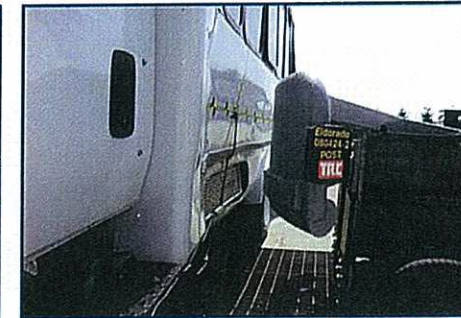
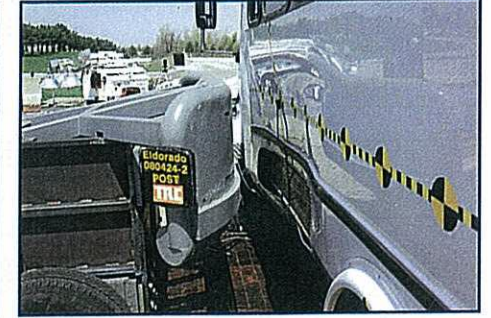
30 mph SIDE impact by a 4,000 lb. moving barrier

Model selected represented the most typical length vehicle however with the highest vertical center of gravity to best measure vehicle vertical stability. All body panel seams and wall to floor attachment points remained intact. Wall sustained an approximate 5" permanent deflection. All windows remained intact with no breakage. All egress windows and entry door remained fully functional. Due to elevation of the face of the moving barrier minimal damage was sustained on the under-floor structure or air conditioning skirt mounted condenser at this location. Vertical stability from impact was minimally affected; nominal 15 degrees at maximum tilt.
